**BURNED-AREA REPORT**  
(Reference FSH 2509.13)**PART I - TYPE OF REQUEST**

A. Fire Name: Lolo Peak

B. Fire Number: MT-LNF-001288

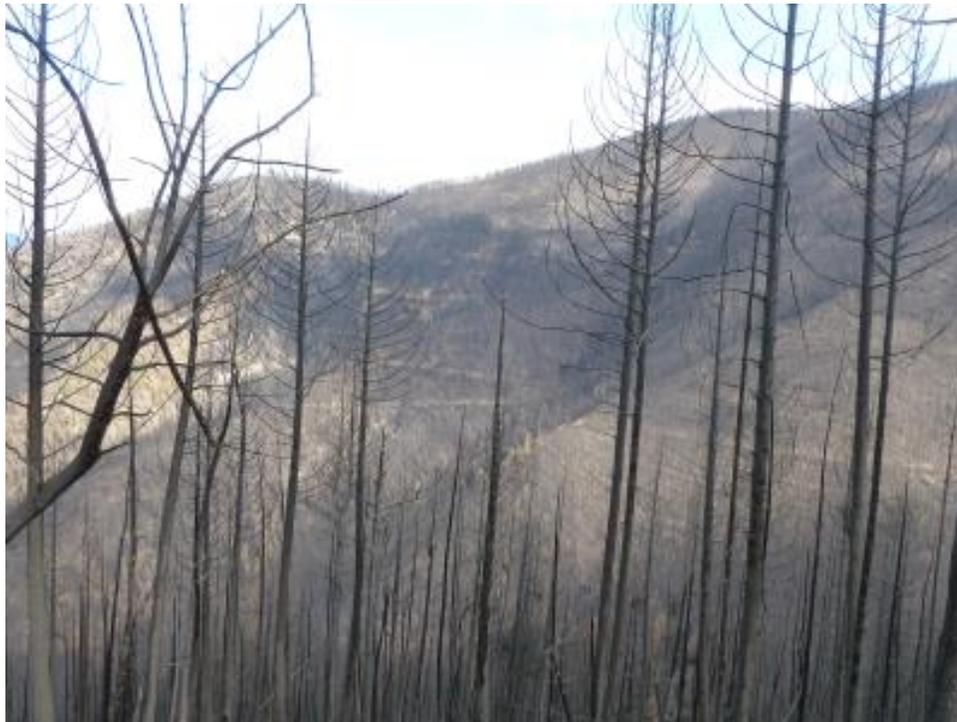
Area of moderate and high burn severity in the Mormon Creek drainage.

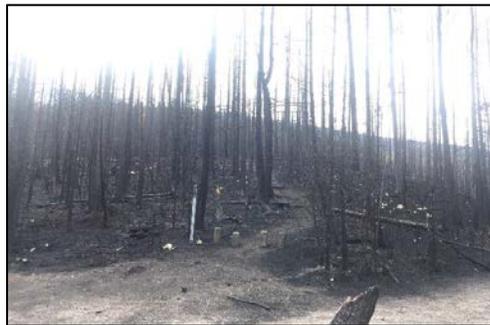
*Example of Trailhead Prevention and Awareness sign (with bootbrush) and the severely burned Lolo Peak TH.*

Signs at trailheads would be installed to reduce noxious weed spread and encourage users to stay on trails. Each sign would also have a boot brush to clean footwear prior to entering vulnerable areas. Signs would be placed at the following trailheads on the Bitterroot NF: Lappi Lake (TR324), Bass Creek (TR4), Holloway Lake (TR393) and One Horse Lake (TR326). Signs would be placed at the following trailheads on the Lolo NF: South Fork of Lolo Creek (TR311), Lantern Ridge (TR309), Mill Creek (TR1310), and Lolo Peak (TR1311).

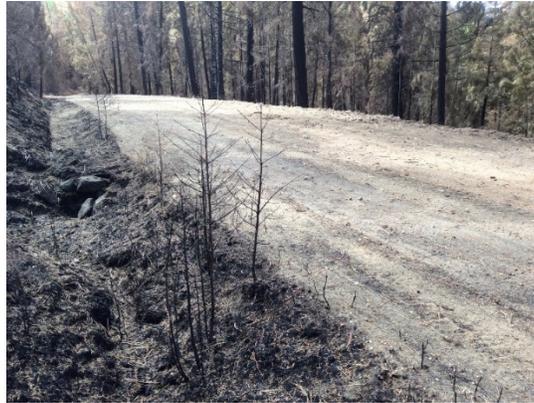
- NFSR 612 [Mormon Peak Road] – Lolo NF: Main arterial cost-share road providing access to private property and a popular trail head (Lolo Peak Trailhead). The roadway is in fair condition with ditch-line, partially plugged cross-drains, larger pipes at major drainage crossings, and rolling dips. The road is along the northern perimeter of the fire, eventually switching back into the burn and running mid-slope through a mixture of low, intermediate, and high burn severity.

- In three draws which experienced intermediate and high burn severity, a potential exists for existing culverts with large fills to be overwhelmed during storm events, directing run-off onto the road prism.

Typical burned condition on Mormon Creek Road NFSR 612

- Culvert upsizing at major drainage crossings

- Installation of armored critical dips
