# Nenana Ridge Experimental Fuel Treatments

## PRESCRIBED BURN June 17, 2009

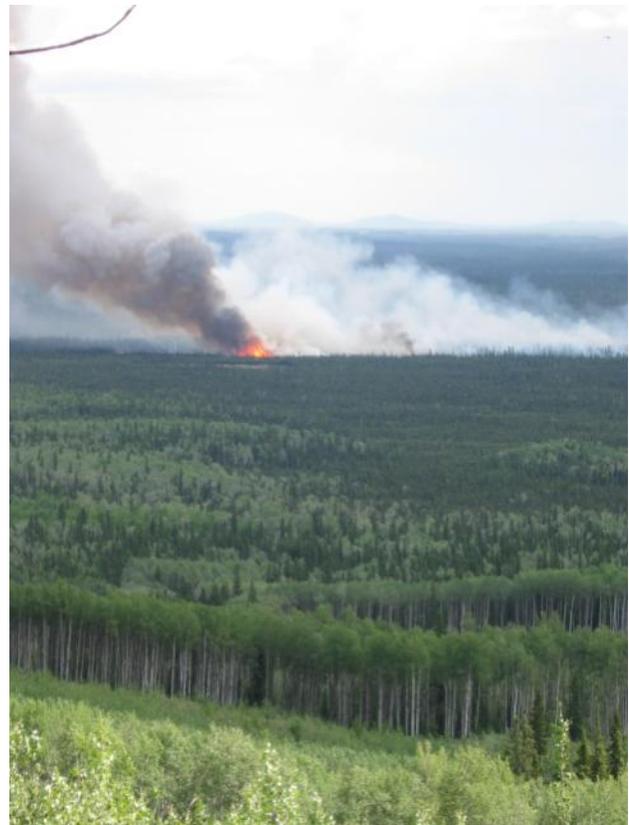
Figure 2. Fire appearance at 15:15, from 2 miles away.

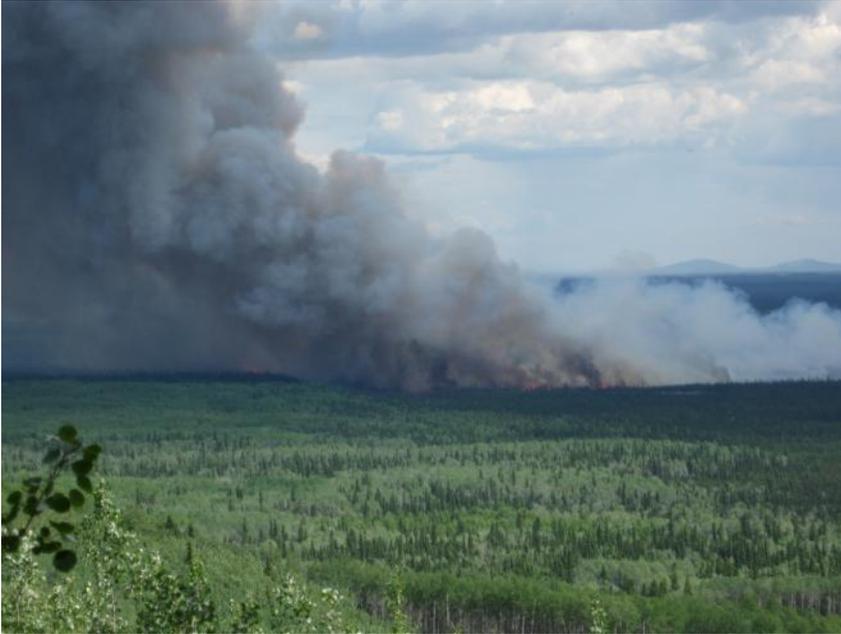
Figure 3. Fire and column appearance at 15:43 p.m. 6-17-09.

1 and B-2 was still in progress. At this time DOF received a complaint about smoke at Denali, but it appears unlikely obscuring smoke would be traveling that far as the column appears to be shearing off at 1000-2000' and drifting and dispersing.

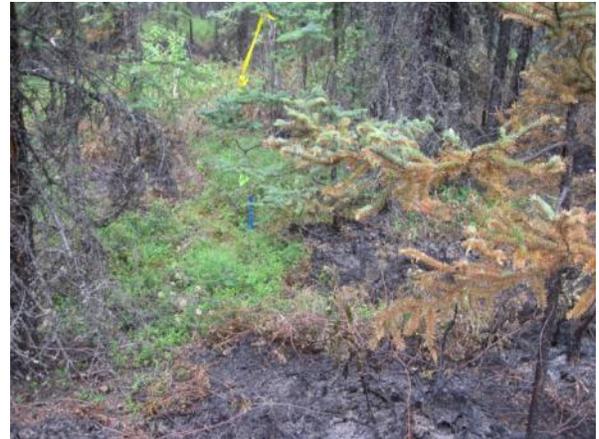
Duff sampling for fuel moistures was conducted in the morning on burn day (4 samples in unit B-3, 6 in B-4 and 4 in untreated controls). Live moss moisture content was 44% (gravimetric) in the morning and about 47% at ignition time near the test burn location. This is on the high side: an FFMC of 92 (which RAWs calculated for that day) should translate into 9% live moss moisture on the ground using Lawson's equation, but local site conditions clearly were not that dry, which contributed to the initial difficulty in getting surface fire to spread in the bottom of the unit (Fig.4, 5).

Figure 4 (below). Low severity and partial canopy consumption between A-1 and A-3 in the lower third of the Unit.

Burn severity was extremely variable from the bottom to the top of the unit. At the southern, lower elevation, portion of the unit burn, severity was much lower, particularly in the tree crowns, which were often unburned (Fig. 4). The middle portions of the A-unit burned with higher severity where drier fuel conditions, more open canopy, convection, and more wind and slope helped build fire intensity.

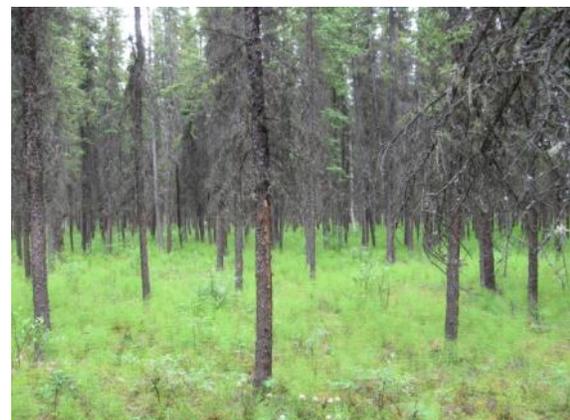
Figure 5. Treatment unit A-2 had taller trees than A-1 (some white spruce) with larger canopies providing a high degree of shading on the forest floor. There was also substantial cover of green horsetail and deciduous shrubs, tending to retard drying of the feather moss in the lower A-Unit.

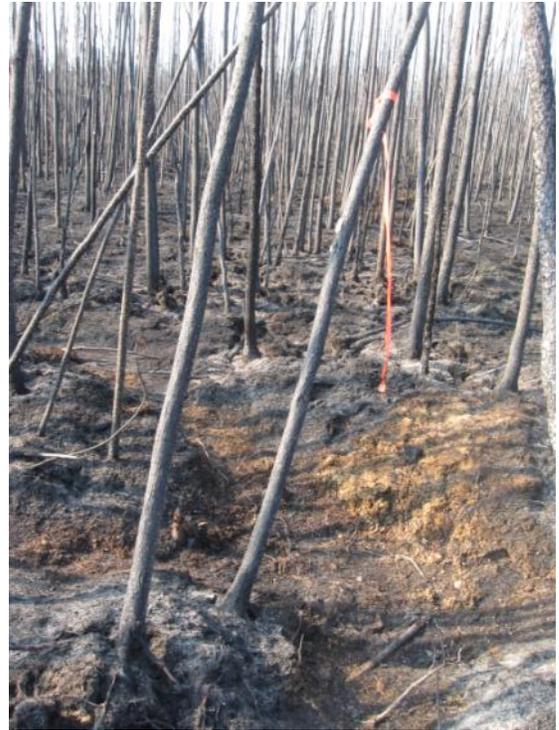
An inspection of the differential char heights, crown effects, twig curling and foliage damage indicates the main challenge of the head-fire to treatment A-1 was from the SSE, with more easterly component along the east side, which is very close to the east control line. Walking paths created by dragging slash during the treatment in 2006 were evident along the eastern edge and ap-

Figure 6. Unit A-1 SW corner marker showing effects of continuous crown fire which entered the treatment from the south.

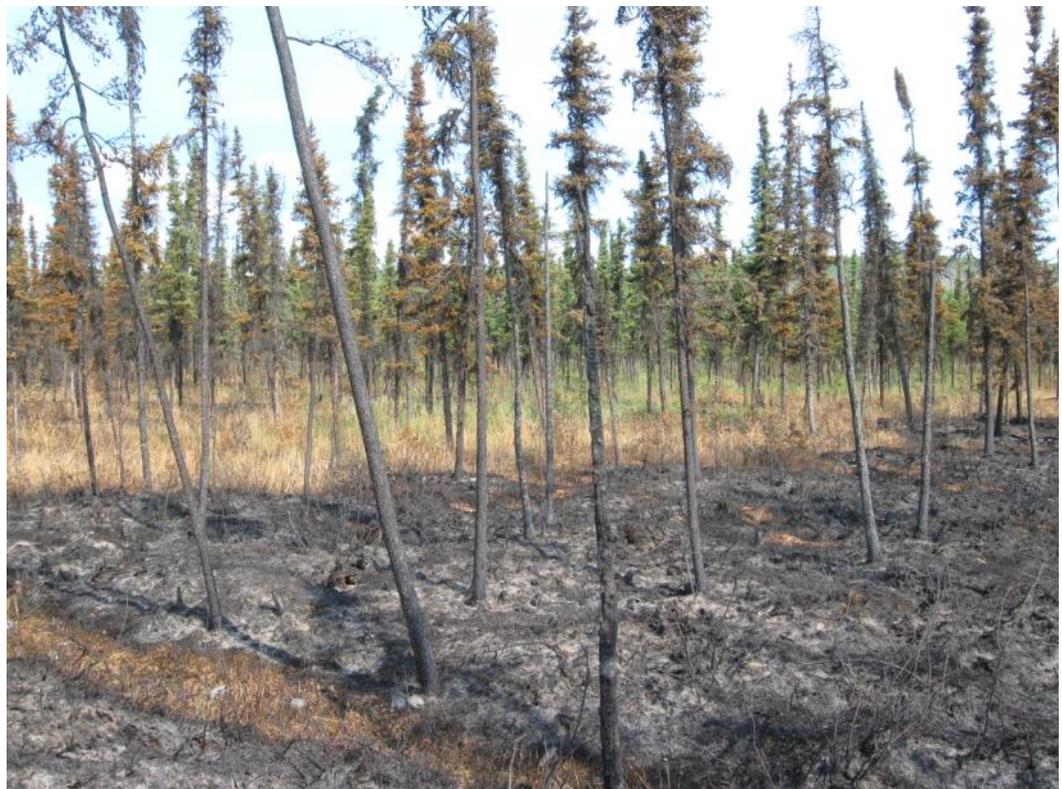
Figure 7. Treatment A-1 from the SE corner looking into the thinned and pruned treatment. Grass was too green and did not carry surface fire well, and tree canopies are mostly intact.

peared to slow fire spread to the north. Forest near the SE corner of the treatment appeared to have a more open canopy and flame height here was less (about 15', as reflected in the scorch heights) than adjacent to the SW corner and in the control plots on the S and W side of A-1. There flame height was over 60' based on complete bole char of tallest trees and removal of 100% crown and most small twigs on trees S and W of the treatment (Fig. 6). Burn severity in general could be characterized as a moderate substrate severity (50% duff consumption but little or no mineral soil) and high vegetation severity (vegetation consumed, 100% mortality). Interestingly, about 10m inside the south edge of the treatment scorch height transitions abruptly to 3-6'. Almost all (95%) crown foliage in the 5-acre treatment is intact, reflecting a high resistance to crown fire (Fig. 7). Surface fire did not spread all the way to the north side of the unit, halting about 1/2 way across, and scorch heights near the middle of the unit were 1-3 feet. On the west side of the treatment, the fire only burned about 4 m into the treated area and canopy scorch was nil. Tree density appeared to be a factor in the severity of fire effects seen east of the treatment: where trees were densely stocked the fire damage appeared more severe (Fig. X). Clearly the grassy areas had higher fuel moisture and were poor conductors of surface fire in the treated area.

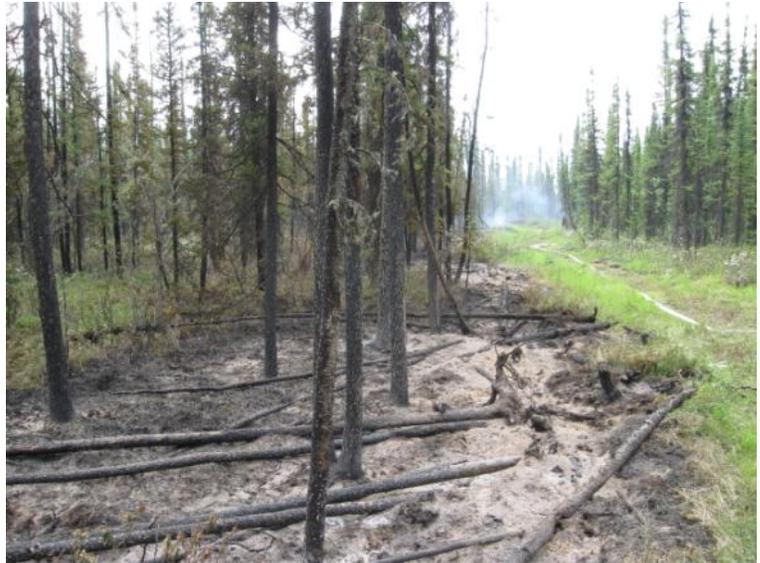
The A-2 thinned treatment and control plots on the south and west remained virtually untouched by fire, because of sluggish fire spread due to high RH and surface fuel moisture conditions in the lower 1/3 of Unit A (Fig.8). Vegetation in this unit (and south of the unit) was lush with taller trees and lush understory vegetation including horsetail, blueberry, lingonberry and Labrador tea. There were a few spots burning north of A-2, showing deep smoldering and felling trees by burning out the roots.

Figure 8. Hand-lit fire on A-B line failed to carry surface fire more than a few meters toward the interior of the A-unit in its bottom third. However, when fire penetrated the moister surface fuels the upper duff was dry enough to be consumed, felling trees.

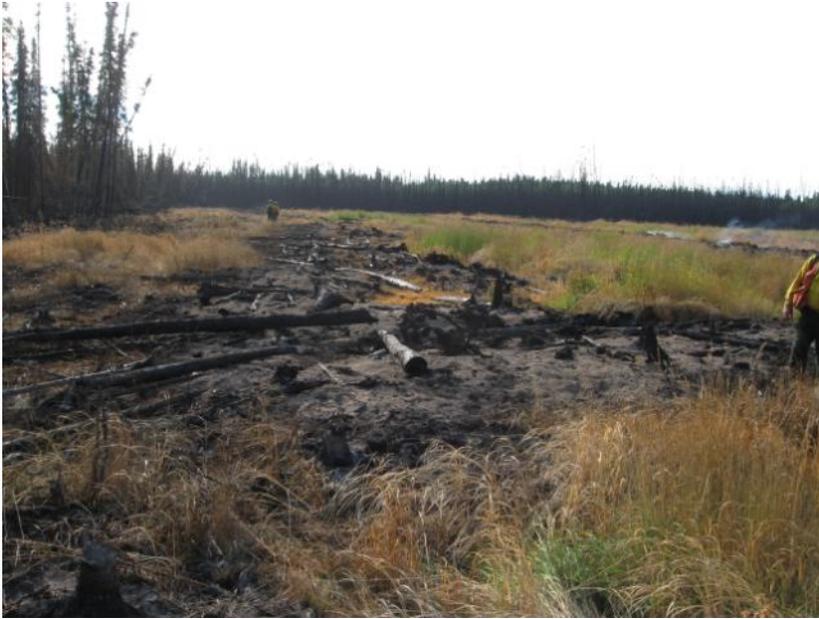
In the shearbladed treatments, the pattern used and the resulting distribution of woody debris had dramatic consequences for fire effects in the units. In the A-4 treatment where fuel was piled into large horizontal windrows and burned, only areas with remnant concentrations of woody material burned, leaving much of the grassy areas between the rows untouched (Fig. 9). In contrast, unit A-3 had woody debris distributed more evenly around the unit, and more remaining since piles were not big enough to burn in the winter. This unit had a high degree of substrate burn severity over much of its surface, particularly in the SE corner where patches of soil appear to be oxidized from sustained heat (Fig. 10, 11).

Figure 9. Windrow after re-burning in shearblade treatment A-4, NW corner looking SE. Note resistance of grass fuels to surface fire spread, likely due to high fuel moisture.

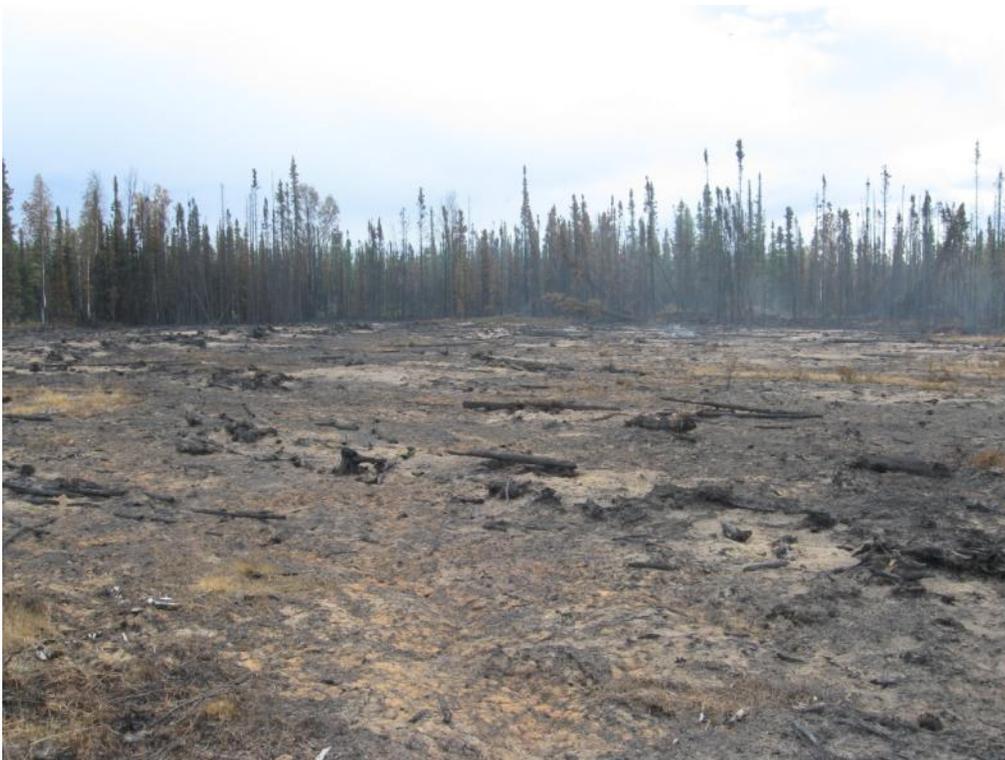
Figure 10. The southeast quarter of shearblade treatment A-3 showing high rates of consumption of vegetation, duff, and coarse woody debris. Red patches are severely burned areas with oxidized soils.

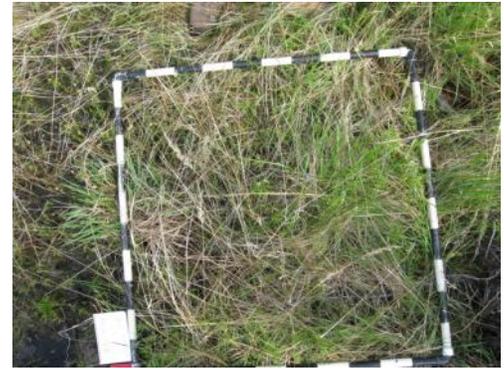
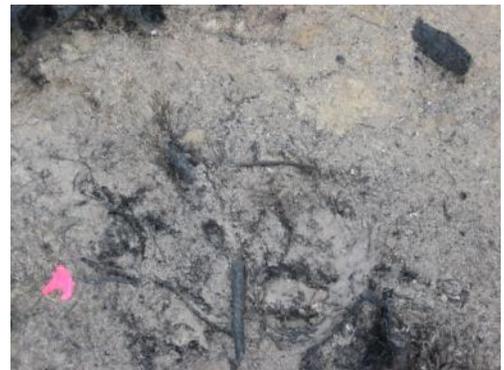
Figure 11. Pre-burn (6-3-09, above) and post-burn (6-20-09, below) photos of a A-3 plot R1P1 in the shearblade treatment.
