**BURNED-AREA REPORT**  
(Reference FSH 2509.13)**PART I - TYPE OF REQUEST**

A. Fire Name: Lolo Peak

B. Fire Number: MT-LNF-001288

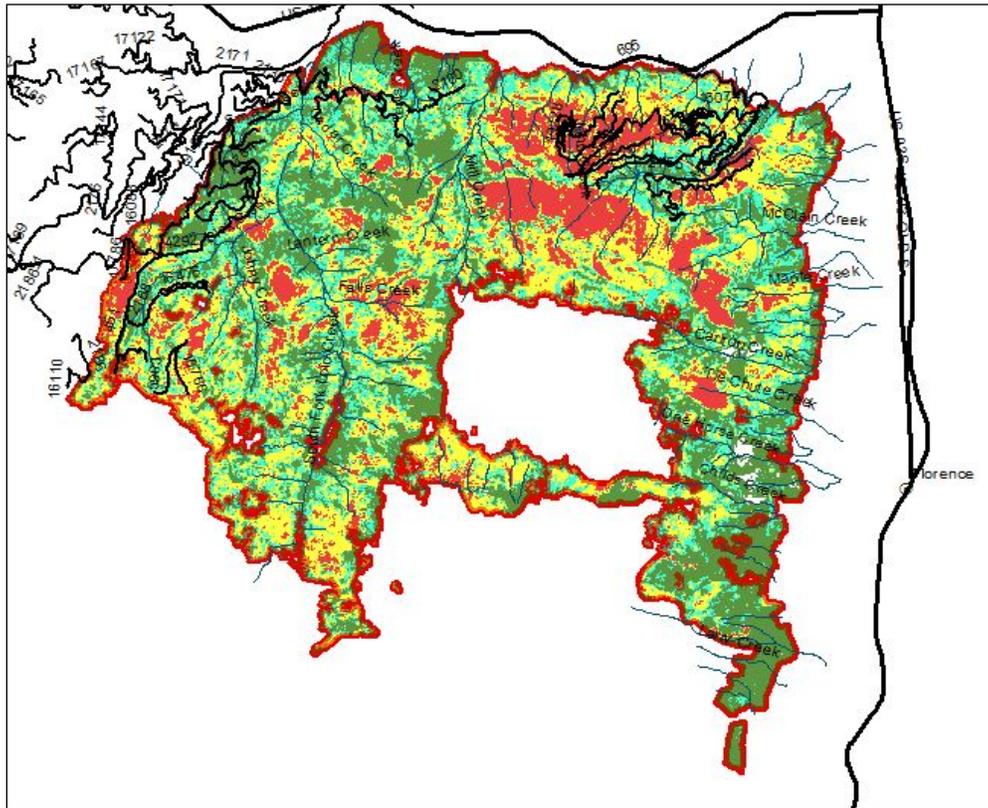
Soil Burn Severity for the Lolo Peak Fire, Lolo National Forest. red = high burn severity, yellow = moderate burn severity, light green = moderate burn severity, dark green = unburned
